Manhole Inspection Summary

Manhole # S49AA_020MH

Insp Date: **5/13/08 8:43 AM**

Location Address: **734 n kenwood ave**

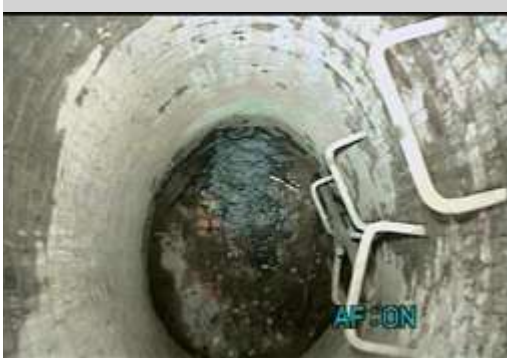
Defect 2

Steps Count: **5** Missing: **0** ☒ **Corroded**

steps

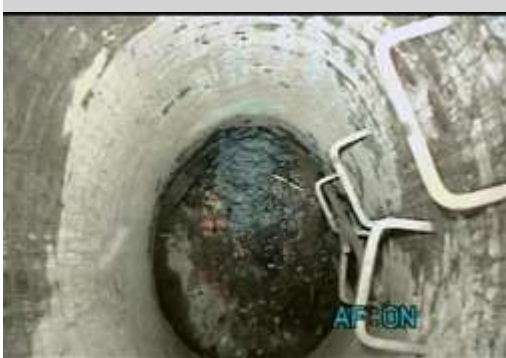
Defect 1

Condition: ☐ Sound ☐ Cracked ☐ Root Intrusion ☐ Deteriorated ☐ Leaks ☒ **Debris**

debris

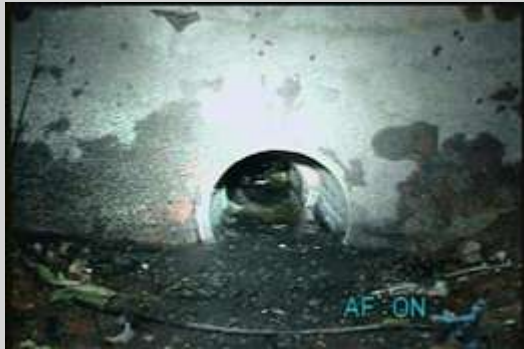
12 O'Clock Outflow

8 in. Circular Gravity Sewer
Pipe Out @ 12 O'Clock

Deposits: ☐ None ☐ Mud ☐ Sludge ☒ **Debris** ☐ Grease

Silt Depth: 1 (in.) Deposits Extent: **Light**
